## Comments and Concerns about the Construction Plans for the Serene Conservancy.

by Dr. Ed Holroyd

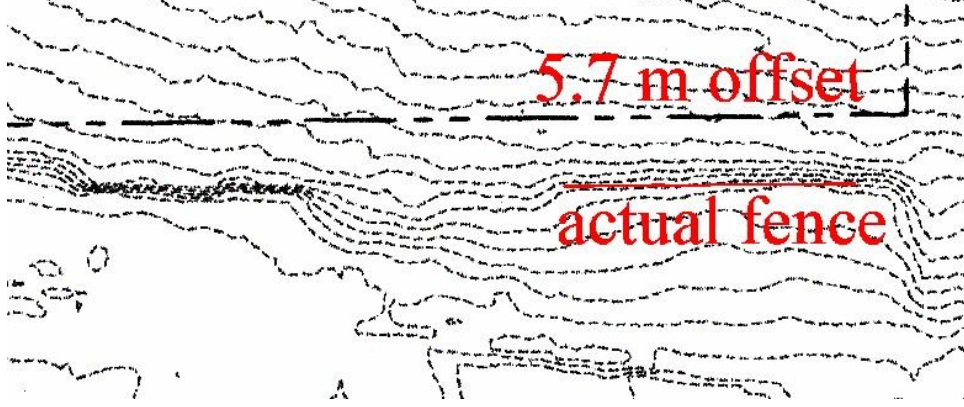
southeast corner

The following extracts show the comparison between the construction map property boundaries and the actual positions. The offsets are measured approximations and should be refined.

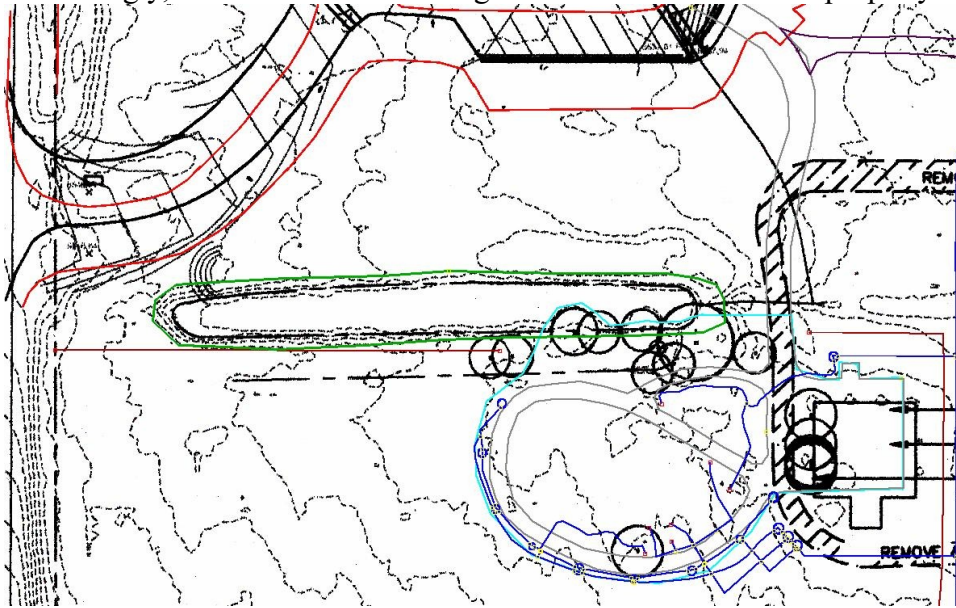
West, entrance pond and safety fence in green

The west pond at the entrance has very steep banks which are of very slippery clay when wet. I erected this fence at the top edge of the cliff edges so that people, running kids, dogs, etc. cannot accidentally fall into the pond.

The playground is likely drawn 5.5 meters too far north and overlaps the pond edge. Correcting the playground map position eliminates the conflict with this safety fence. This fence should not be removed because of the expected nearby activities.

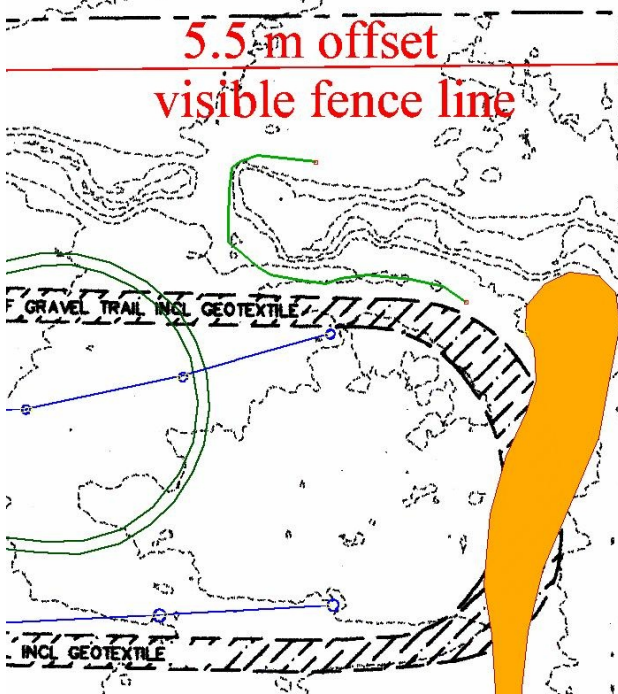
Northeast corner, Van Bibber Creek safety fence

Early this year when the general public began much use of the gravel trail for walking themselves and dogs, I noticed how close they got to the collapsing banks of the Van Bibber Creek. It was an obvious safety issue. So I erected the fence indicated as the medium green line. The dark green circular green is the proposed grassy pathway of the construction proposal. The yellow area is a cut for drainage. The blue features are parts of the irrigation system. The 5.5 meter position error could be present in the Construction features.

To the west of the small culvert the creek banks are not collapsing and are adequately away from present and future pathways. So a fence does not seem to be needed there. My new fence does not interfere with future plans. It provides safety for people who wander off the designated pathway. Its open ends allow people into the safe parts of the creek edges, such as for dog watering and plant inspections, if they wish to do so. So I recommend leaving this safety fence in position as the banks continue to collapse and erode.

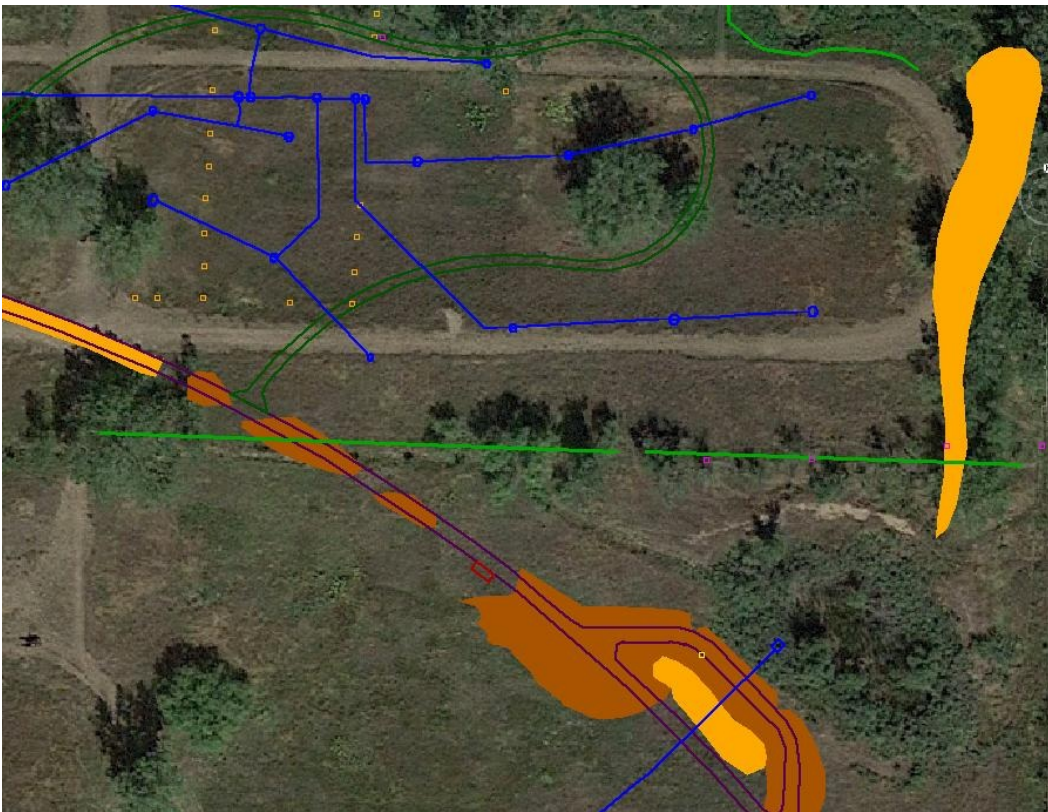
Middle fence, shown as straight green lines.

The west end of the middle fence is on the north rim of the central ditch. The east end used to continue to the property line. It is shown as a pair of straight green lines. The gap in the middle is for the passage of deer and coyotes. It was an existing fence. It does not have a major safety purpose and can be removed. The ditch can be an inconvenience to travel across the field, especially when wet in the Spring, but is obvious to a walker.

This fence needs to be cut anyway by the crusher-fine pathway (dark red parallel lines). The yellow areas are cuts and the orange areas are fills. The blue features are proposed irrigation components. The curved green parallel lines are the grassy path. The tiny orange squares are existing wooden posts, some of which may be removed. Though the crusher fine pathway appears to be properly located, some of the other construction features may have the 5.5 meter position error.

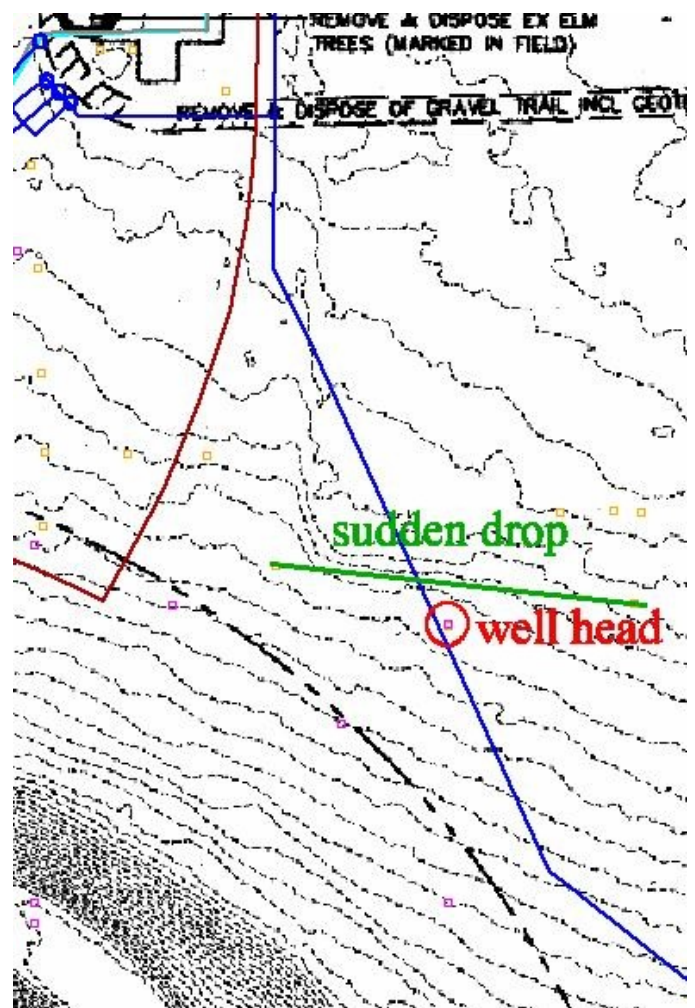
Southwest fence as green line

I erected a fence line on the southwestern slopes as the southern boundary of a large area being seeded with prairie grass. A large mound had been removed and used to partly fill a depression where there had been a greenhouse. Eventually I dismantled much of that fence line. However, I left intact the indicated segment. Its west end provides a mild safety feature so that casual walkers in the field do not get surprised by the sudden drop in elevation. In the illustration the red line is the proposed rail fence line, adjusted about five meters southward. The dashed black line is the property boundary which is about 5.5 meters too far north on this mapping.

The blue line is the proposed irrigation supply pipe. To avoid the sudden drop in elevation, I suggest that the irrigation pipe be diverted around the west end of this fence on its way to the picnic area. As drawn it also crosses a hidden well head pipe (circled red square just below the green line) that I have marked in the field with a T-post.

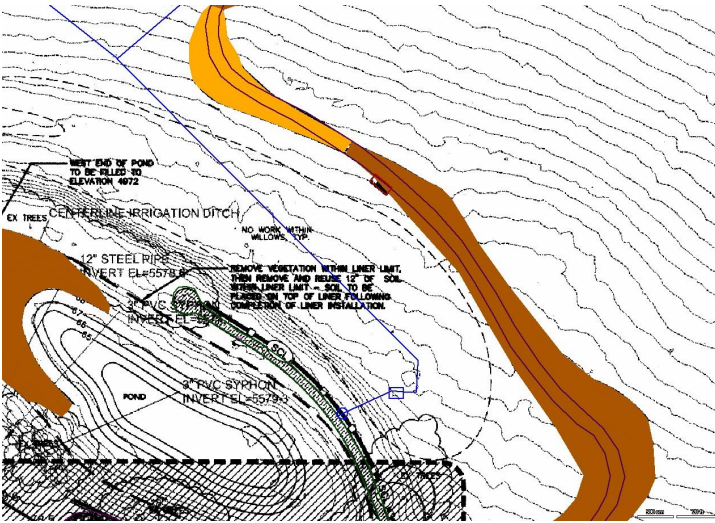
The small central message says "NO WORK WITHIN WILLOWS." The thin dashed line approximates the extent of the willows.

present it is very challenging to walk through those willows because of interlocking curved dead branches. The yellow area is a cut; the brown areas are fill. The parallel dark red lines are the crusher-fine pathway.

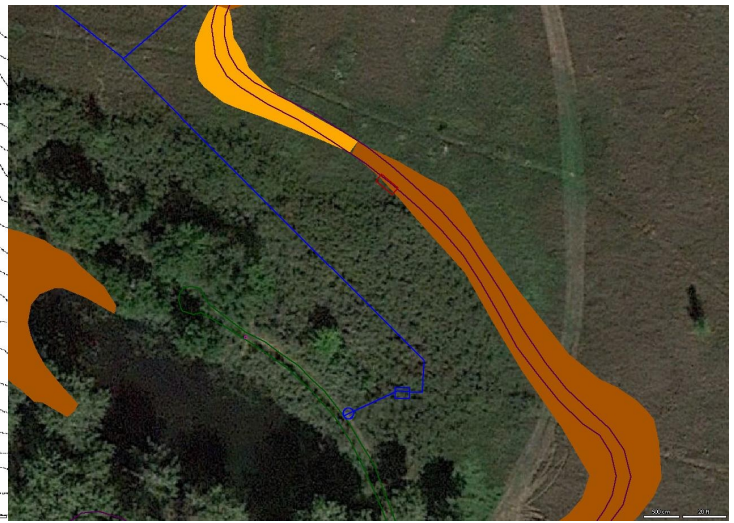
The blue irrigation pipe line runs in the middle of the willows. irrigation pipe location passes right through the middle of them. That will create a major construction scar.

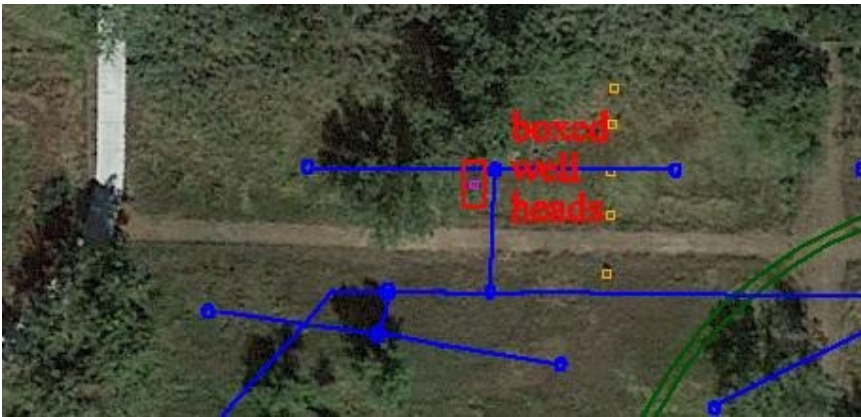
North part of gravel trail, west end, with wells (red) and posts (yellow)

Under the large cottonwood trees north of the northern gravel trail (levee) are two large circular wells now covered with a

wooden rectangular box. As drawn, the irrigation system cuts through this well location. However, if the irrigation system suffers the typical 5.5 meter offset to the north, a corrected position will avoid interfering with that large well.

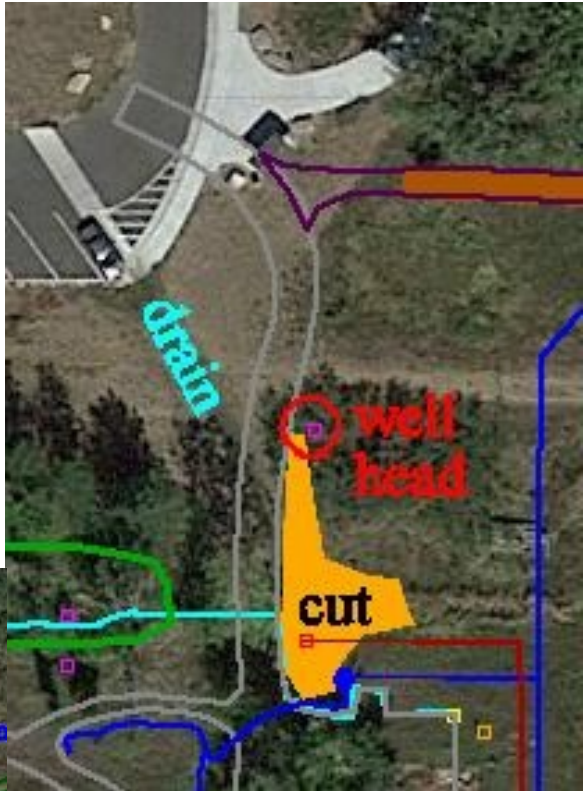
Access path to picnic and playground areas

As previously mentioned, the picnic and playground drawings appear to suffer from the 5.5 meter offset, making them farther north on the terrain than they should be. In the illustration, the gray parallel lines show the proposed concrete pathway from the parking lot to the picnic and playground areas, without correction for the position error. The diagrams do not mention a drainage pipe under the concrete path to accommodate the drainage from the parking lot. They do not mention the pipe from the entrance pond to the middle drainage ditch. They do not indicate the major well head facility hidden in the willows. Though the rest of the crusher-fine trail (maroon lines with orange fill) seems to be properly positioned with respect to the terrain, this ending near the parking lot suffers from the 5.5 meter offset of the rest of the construction features in this area.

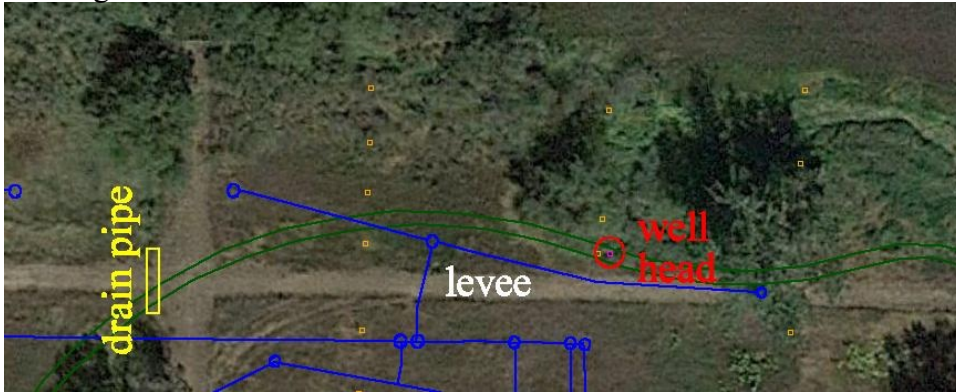
Water-related features in the central north, adjacent to Van Bibber Creek

Farther east at the northern gravel trail intersection is a large pipe that lets excess water drain northward to Van Bibber Creek (at the top edge of this view). During the September 2013 flood the gravel trail functioned as an important levee, keeping most of the flood water to its north side. However, water flowed southward (backward) through the drain pipe, permitting a flooding within the eastern loop of

the gravel trail. If not for the southern part of this loop also functioning as a levee, the flood water would have reached the drainage ditch that leads to the eastern pond. (See later drawing) The construction plans show no knowledge of this important drain pipe, nor the importance of the gravel trail as a levee.

There is another hidden well head, shown in the image as the circled red small square. As drawn, the proposed grassy trail passes over it and parts of the proposed irrigation system are nearby. At that location the grassy trail passes too close to Van Bibber Creek and under low-hanging tree branches. If the construction drawing of these features suffers from the 5.5 meter position error, a corrected position about 18 feet to the south would avoid the conflicts.

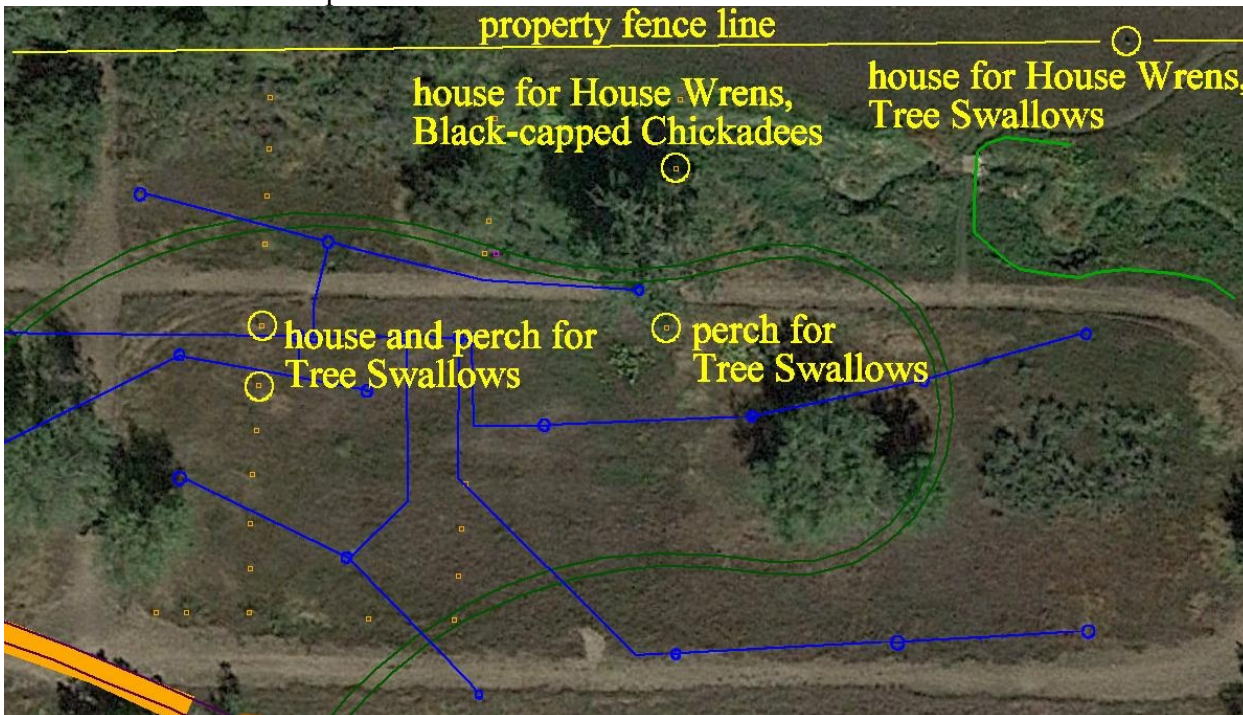
These marked posts should be saved for the birds.

These other wood posts are occasionally used by Robins, Flycatchers, Swallows, and others.

The birds will use them if not removed.

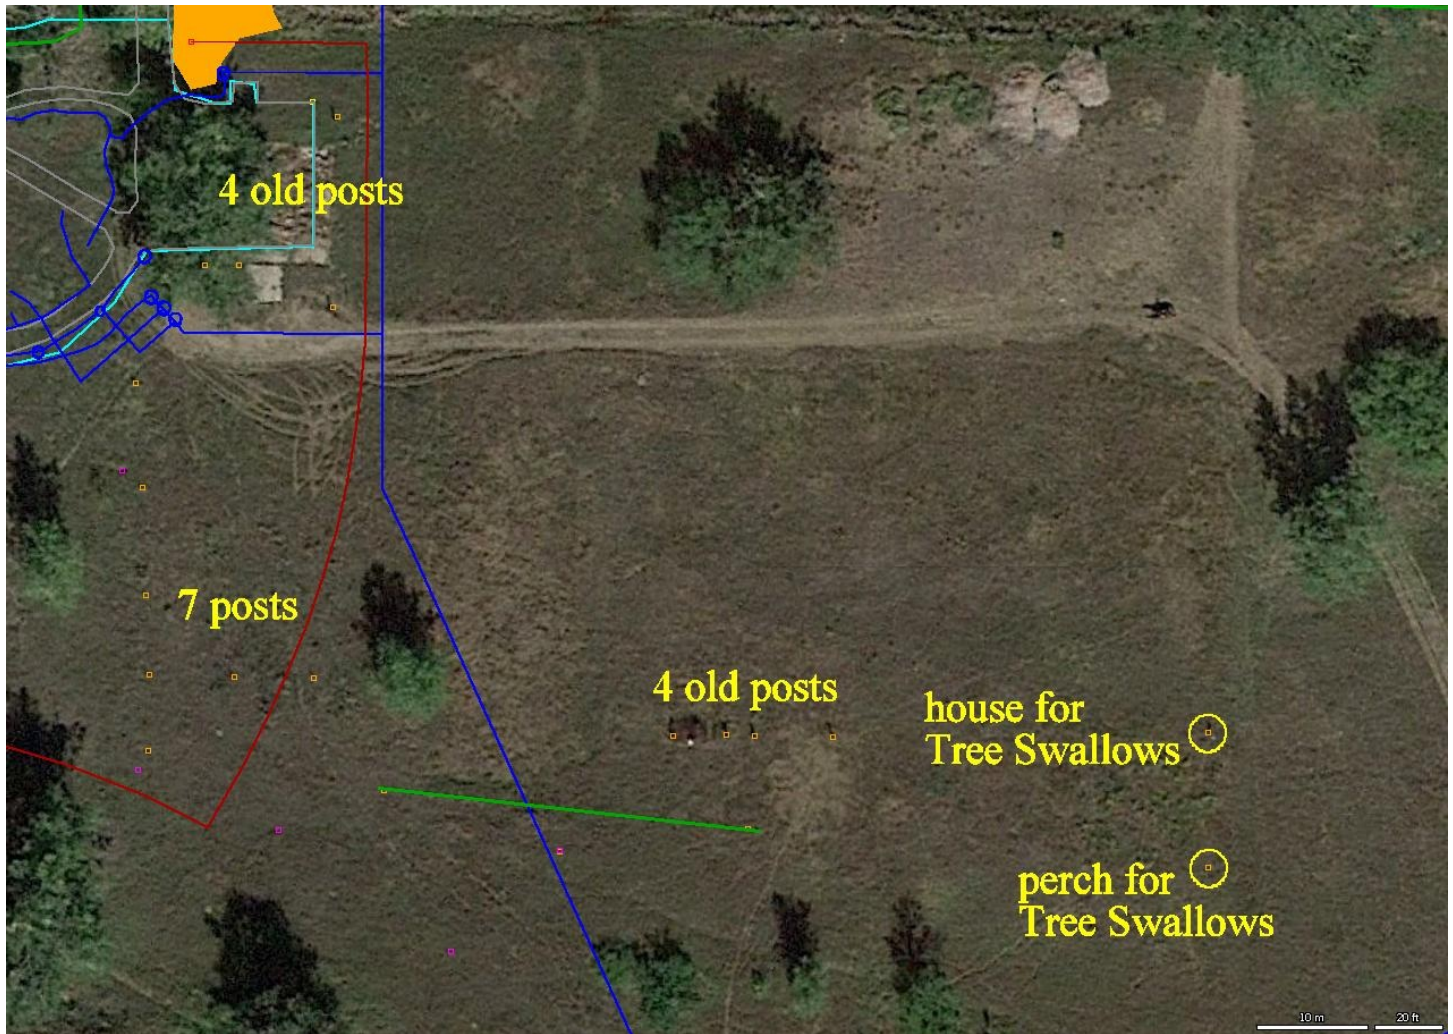
central posts

In the central area are numerous posts. At the right side of the illustrated area are two posts that have always been used by Tree Swallows and should be saved. There is no proposed construction there anyway.

West of there are 4 large and old posts from a former fence line. They are not serving an important purpose but are not interfering with construction plans. It does not matter much if they are removed or left standing. That has also been a storage area for salvaged wire fencing. Repairs for the safety fencing have come from these supplies.

At the left side of the view are two lines of posts with a total of 7 small wooden posts. There is another post lying on the ground near one of them. Apart from occasional perches, these are not serving an important purpose and can be removed. Some must be removed for playground construction and for erection of the new rail fence.

In the picnic area, with the existing concrete pad, are 4 large and old posts. It is expected that all of them will be removed during construction.

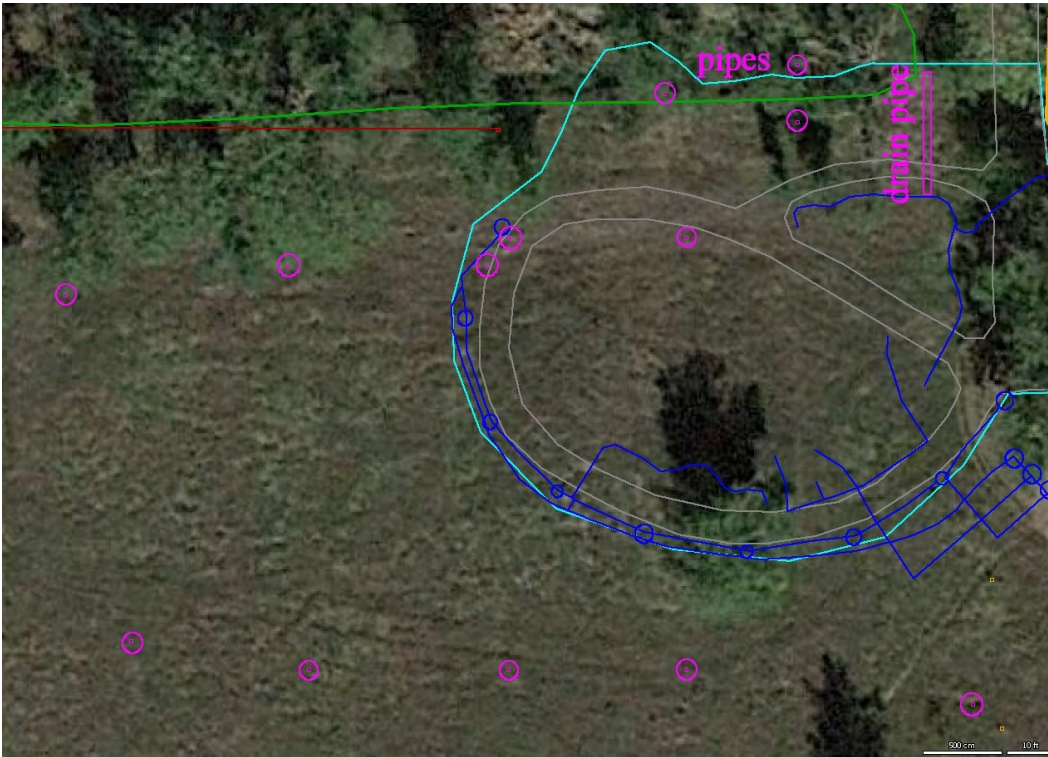
Playground area

The construction plans as drawn for the playground likely have it positioned about 5.5 meters (18 feet) too far north of the actual field locations. Rather than circling the large existing tree, a concrete pathway cuts through its location.

Along the axes of the troughs between the gravel ridges are pits shown by the magenta circles (with only crude GPS accuracy). The pits likely contain large stones, the remains of plastic plant buckets, and possible black cloth. These appear to be functioning as drains. If so, there may be hidden drainage pipes running N-S

between them, following the alignment of the troughs. In the upper right of this view there are pipes of different sizes that serve a drainage function. The construction plans do not notice the large drainage pipe, nor the large pipe (not shown here either) under the driveway that connects the entrance pond to the central drainage ditch. During construction the drainage of the playground area needs to be properly addressed. (There are more pits to the west of the illustrated area that will not be interfering with construction plans.)

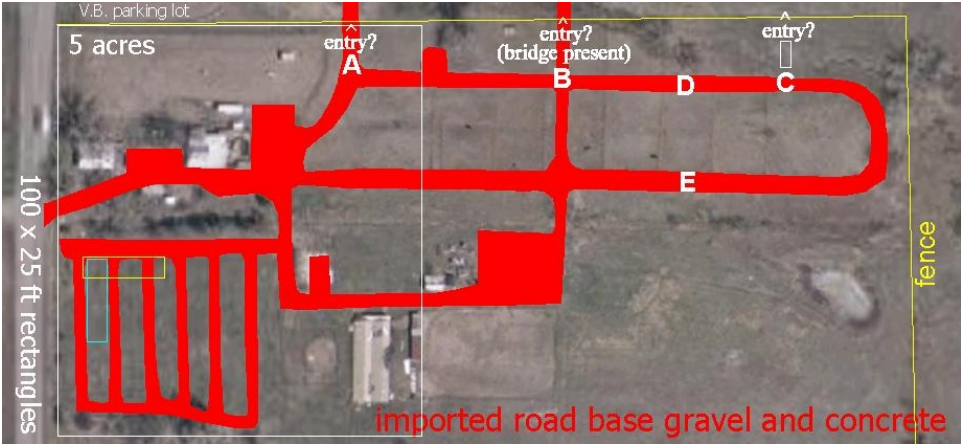
In the 1979 aerial photos of the property the tall ridge north of the new parking lot is not present. It was built to protect the former farm buildings from 100-year floods of Van Bibber Creek. The gravel trail loops are not present either. Page 4 of the construction plans indicates that the gravel trail materials are to be removed and disposed of. It is expected that they are about 8 to 12 inches thick of boulders, gravel, and

sand. They are wider than drawn. This illustration, previously drawn in 2007, shows in red all areas of imported gravel and concrete on an older aerial photo that shows the former farm buildings. Note that the southern loop has a huge area of gravel previously used for parking and not noted in the construction plans.

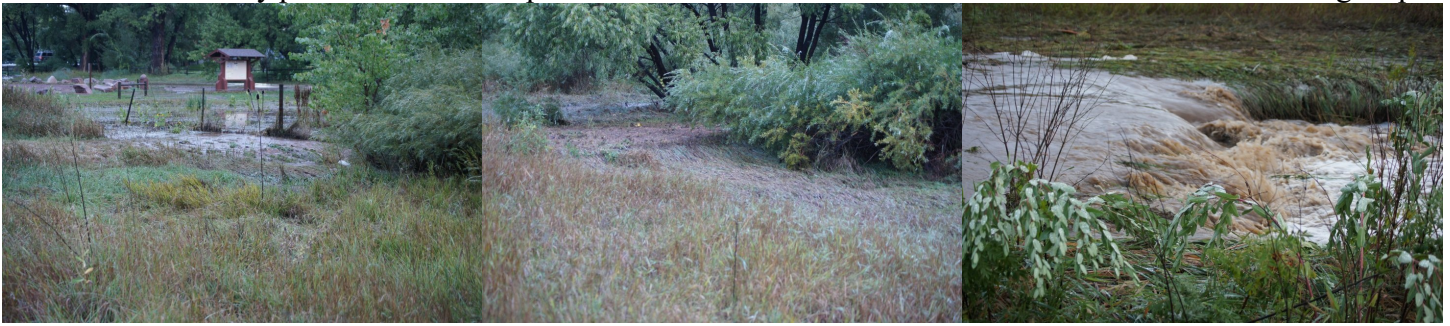
21. Flood water arriving from old parking lot, position A.

17. Flood crossing gravel path at B.

14. Flood crossing grassy path at C.

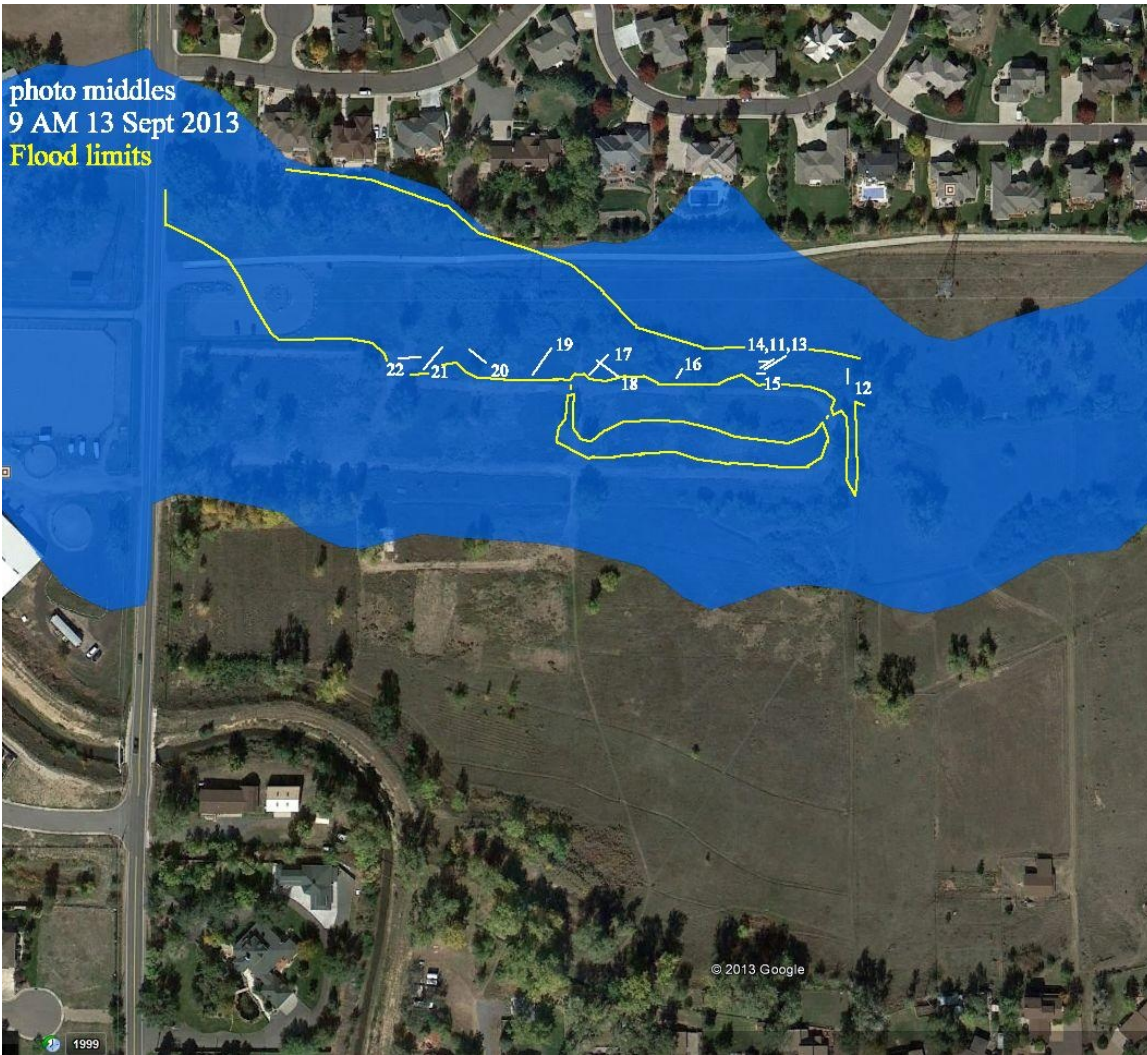
100-year flood plain (blue) with extents of 13 September 2013 flooding, photo locations.

The photos were taken after the flood waters had reached their peak and were receding. The tall ridge north of what is now the new parking lot was the first barrier to the flood. Thereafter the northern part of the gravel trail functioned well as a levee, confining most of the water to its north.

It was a drainage pipe at the trail crossway that flowed backwards, allowing water to flood the interior of the eastern loop. The south part of the eastern loop likewise functioned as a levee. Otherwise the water would have continued to the drainage ditch in the middle of the

property that leads to the eastern pond. Removal of the gravel trail system will enable more frequent flooding of the lowlands of Serene Conservancy.
